Hydrogen Incidents and Lessons Learned

Nick Barilo Executive Director, Center for Hydrogen Safety April 17, 2024

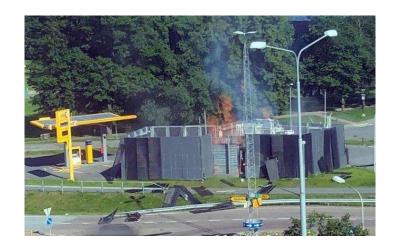
Fueling Station Tank Leak, Fire and Explosion

A leak from one tank within a high-pressure hydrogen storage unit serving a hydrogen vehicle fueling station resulted in a jet fire and an open-air deflagration

- An assembly error of a specific sealing end plug for the high-pressure hydrogen tank
 - The inner bolts of the plug had not been adequately torqued, allowing seal failures to progress into an explosion and subsequent jet fire

Implement rigorous assembly, double-witness verification, and documentation/marking procedures for hydrogencontaining equipment

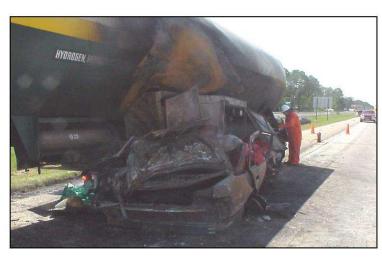
H₂ Liquid Trailer (14k gallons) is Broadsided

The car and hydrogen trailer after the fire was extinguished

- Driver in opposite lane swerved and went across median, slamming into LH₂ trailer
- The gasoline in the car caught fire
- The shell of the hydrogen trailer withstood the impact with no loss of containment

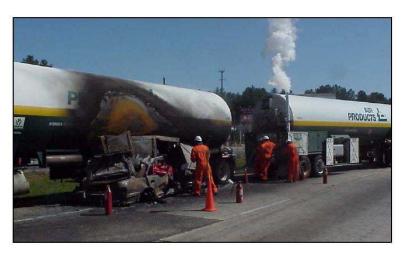
The vehicle recovery team led a safe and successful transfer of all liquid hydrogen from the damaged trailer to another one

Successful liquid transfer following the accident in Louisiana

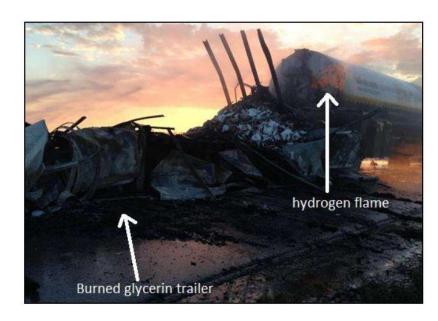
H₂ Liquid Trailer Rear Ended at High Speed

The valve used to pull vacuum between the inner and outer shells was damaged. This resulted in a loss of insulation. This and heat from fire increased the temperature of the LH_2 and built pressure, which vented through safety valves as designed.

Total vent time: 30 hours (for 3,000 gallons)

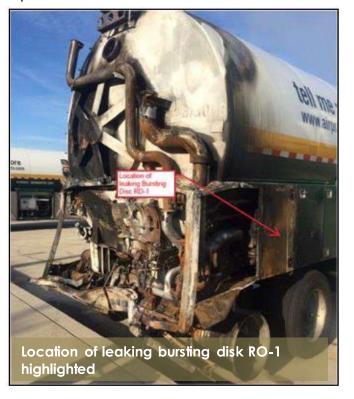
Stationary LH₂ trailer hit by glycerin tanker at high speed. Diesel fire ensued.

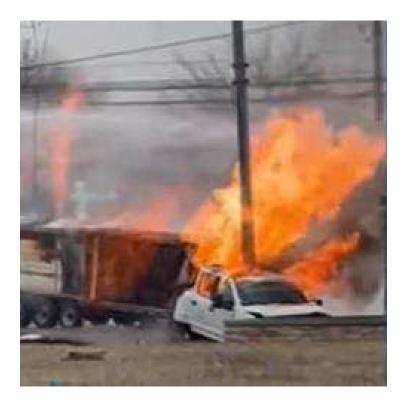
Traffic Accident Involving H₂ Storage Trailer

- A traffic accident with a passenger vehicle led to loss of control and leaving the roadway at the intersection
 - F350 Dual Rear Wheel tow vehicle
 - Light Duty tri-axle trailer carrying two vessels "tube bundles"
- Impacted traffic light pole and ditch on the side of the roadway
- Full loss of hydrogen containment (240 kg)
- Damage
 - Three minor injuries
 - The trailer and pickup truck were both a total loss from the impact and fire
 - Damage to light pole and overhead wires

- The method of anchoring the tube bundles to the trailer allowed for movement
 - Movement of bundle combined with gooseneck deformation allowed contact
- Vent piping appears to be insufficiently supported for PRD reaction forces
 - This led to the non-vertical venting of hydrogen
- Trailer and tube bundle frame appear to have been insufficient to protect piping in this accident
 - Line shear plus open valves may have played a role in the initial hydrogen release
 - PRDs may have played a role in the initial hydrogen release
 - Vent piping may have been inadequately restrained to withstand impact
- Ball valves might have failed to provide containment
 - The impact may have opened valves
 - Impact broke the stem of at least one valve
 - Packing/Seals damaged in fire likely led to further leakage
 - Packing/Seals damaged in fire may have allowed valves to open

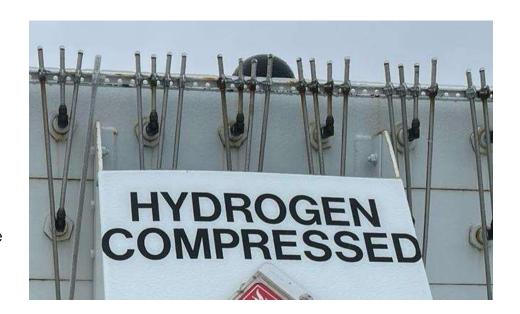
Trailer Vent System Weather Protection

- The tube trailer was located at a customer location
- Water entered the vent stack
 - Vertical discharge but no caps
 - Weather-related
- Water froze during inclement weather
 - Abnormal for area
- Ice plug pushed against and damaged a rupture disc
 - Rupture disc activated and led to loss of containment
 - The vent system remained in place, minimizing the consequences
 - No ignition, well-sited
 - Must replace remaining devices since they may have been damaged
- Lessons learned
 - Provide weather protection to vent outlets
 - Blockages can also damage relief devices

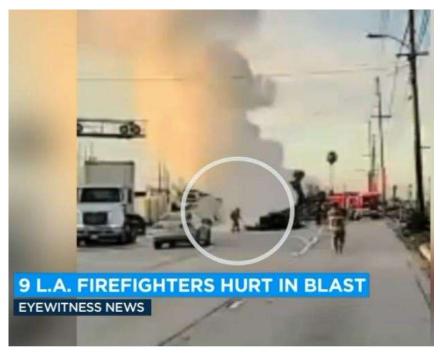
CNG Incident – February 2024

- A semi-truck's 100-gallon compressed natural gas tank exploded while firefighters attempted to extinguish the flame
 - Nine firefighters were injured during their response to a natural gas-powered semi-truck fire.
- The storage system's similarities to hydrogen highlight the need to ensure first responders have the information necessary to mitigate hydrogen incidents safely
- ► The US National Transportation Safety Board is currently investigating the incident
